COMPLETE RESTORATION, LLC

Name of Tank: MAYS LICK

Date of Inspection: 11/03/2022

150,000 Gallon E.W.T.

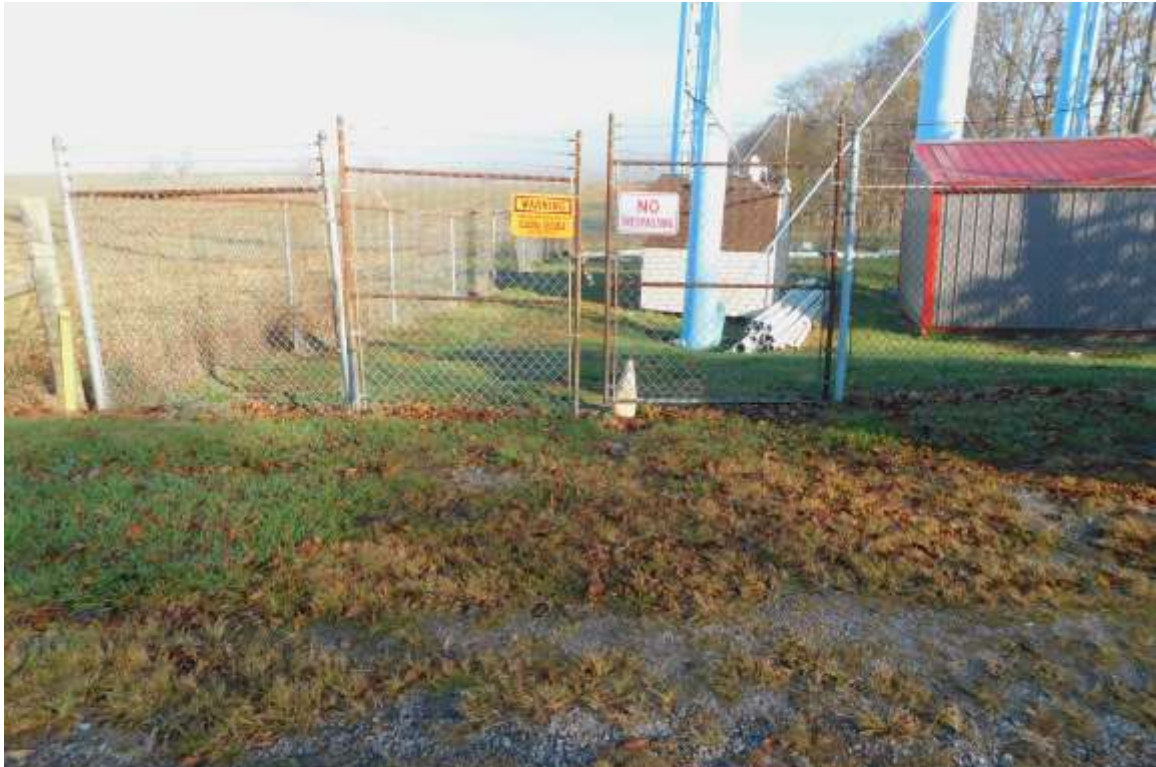
Notice the site is marked to identify the storage tank site security status.

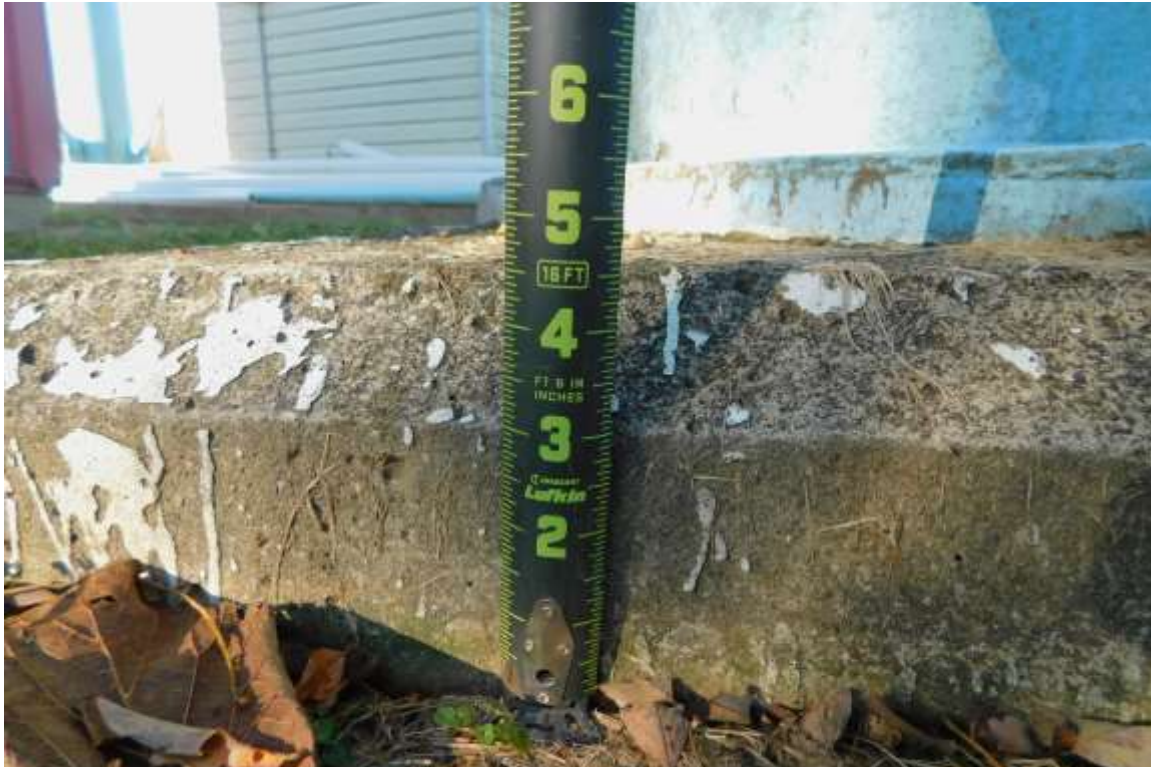
Photo shows the condition of the foundation. **AWWA D100-11 Sec 12.7.1** states *“Height aboveground. The tops of the concrete foundations shall be a minimum of 6 in. (152 mm) above the finish grade, unless otherwise specified.”*

Clear topsoil away from the tank foundation, down to a minimum 6" below top of foundation. The grade should be slopped to provide positive drainage away from the tank foundations.

This work should be done by a local excavating or landscape company.

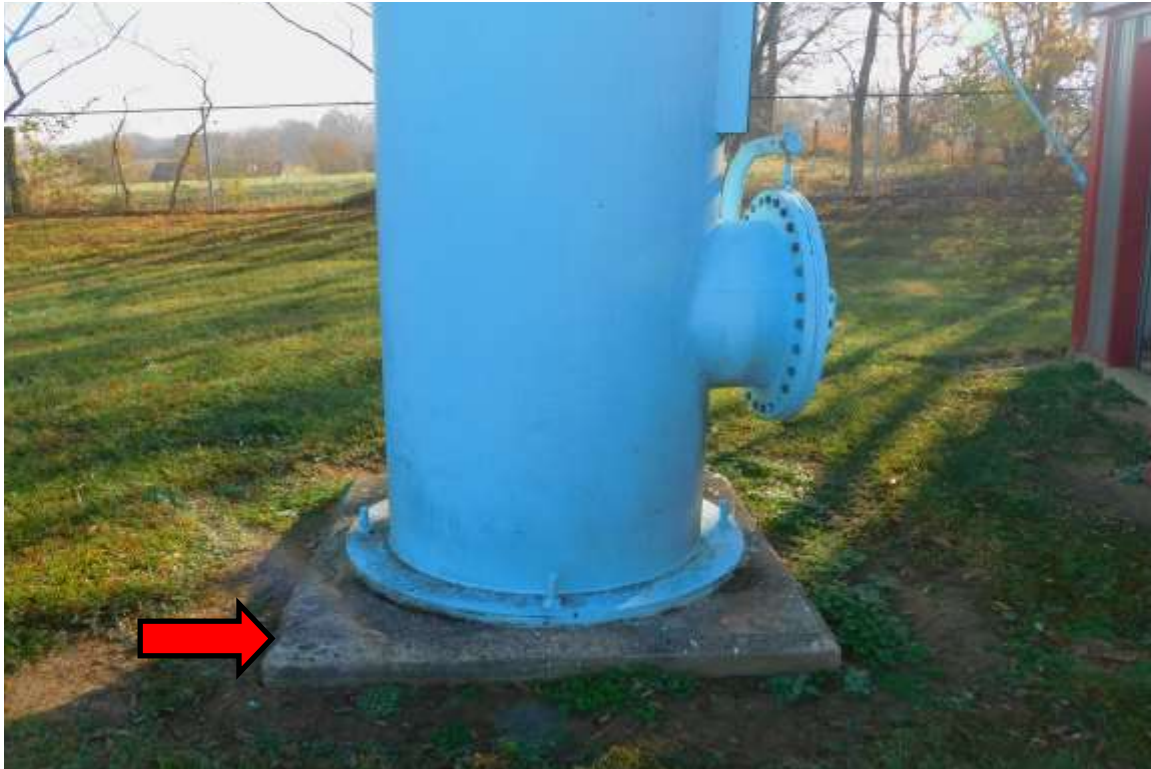
Photo shows the condition of the tank foundations. Notice the cracks and spalled areas.

Repair all cracks and spalled areas by installing a commercial patch.
Seal the foundations with a sealant.

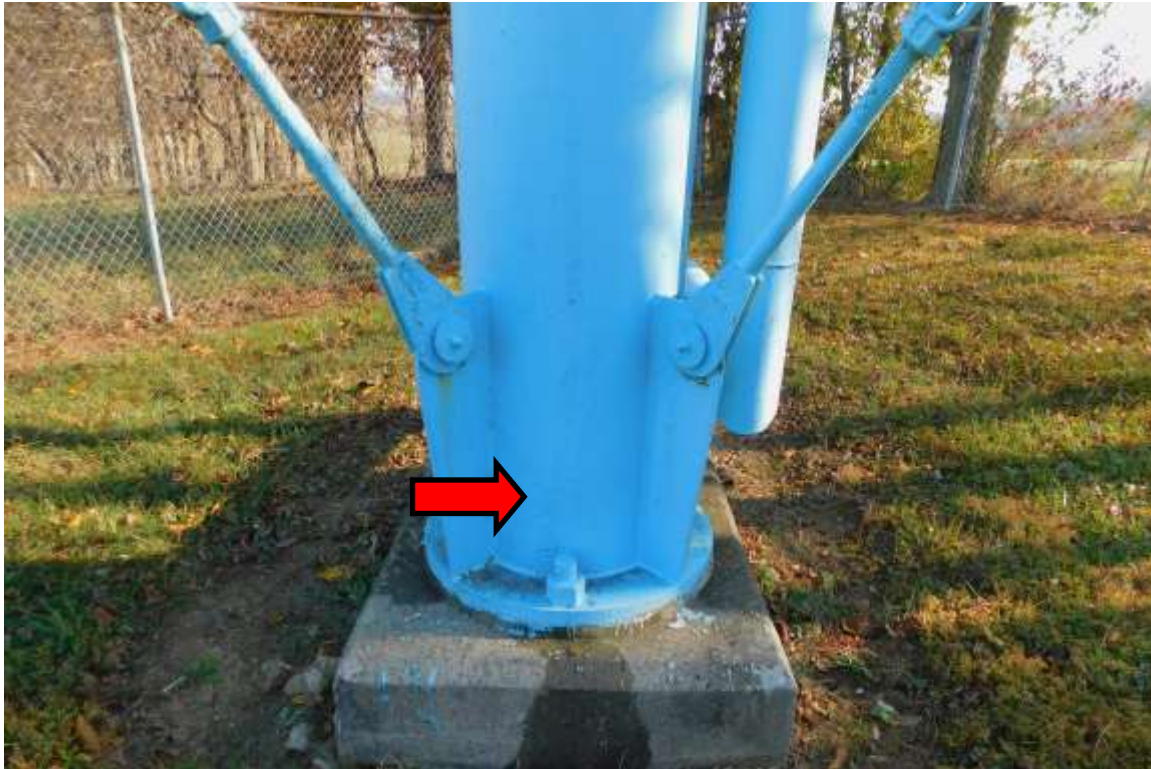
Notice the tank is not electrically grounded for lightning protection. **NFPA 22-2018 Sec. 4.9** states *“To prevent lightning damage to tanks. Protection shall be installed in accordance with NFPA 780.”*

Electrically ground the tank for lightning protection.

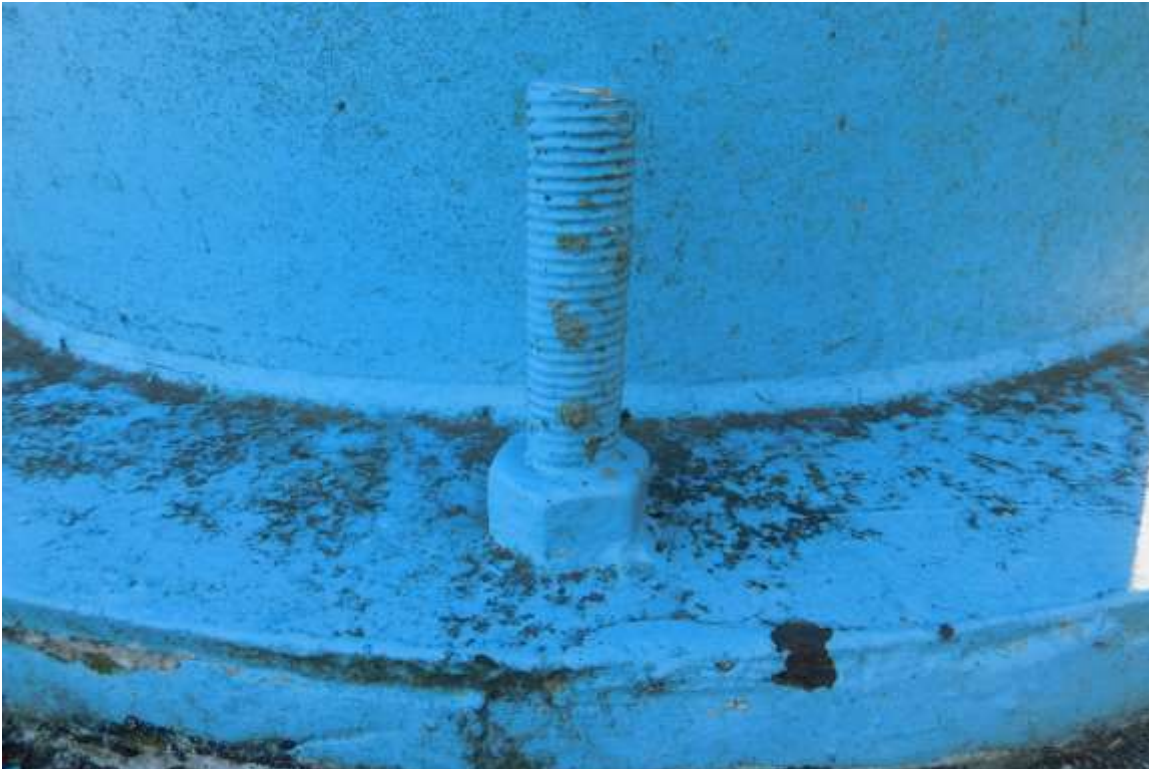
Photo shows the condition of the anchor bolts. The bolt to nut connections are tack welded and in good condition. **“AWWA D100-11 Sec. 3.8.5.1-(5)(b)** states *“For all other bolts, lock nuts shall be provided or the threads shall be peened to prevent loosening of the nuts.”*

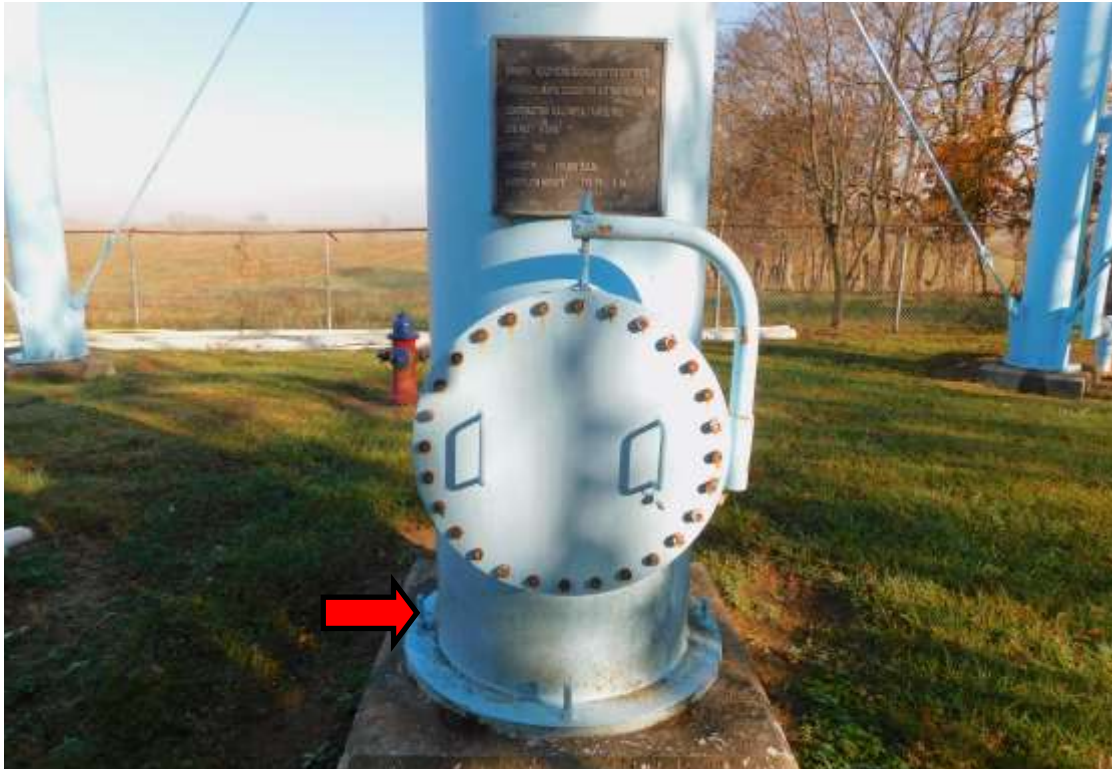
Photo shows the base of the riser pipe. Currently there is no riser drain valve. A drain valve performs two functions it allows the tank to be drained and it is used as a blowout to remove silt and scale from the lower portion of the tank.

- Install a frost proof drain valve.
- Install a locking device to prevent unauthorized draining.
- Install a 4' x 6' splash pad to prevent erosion.

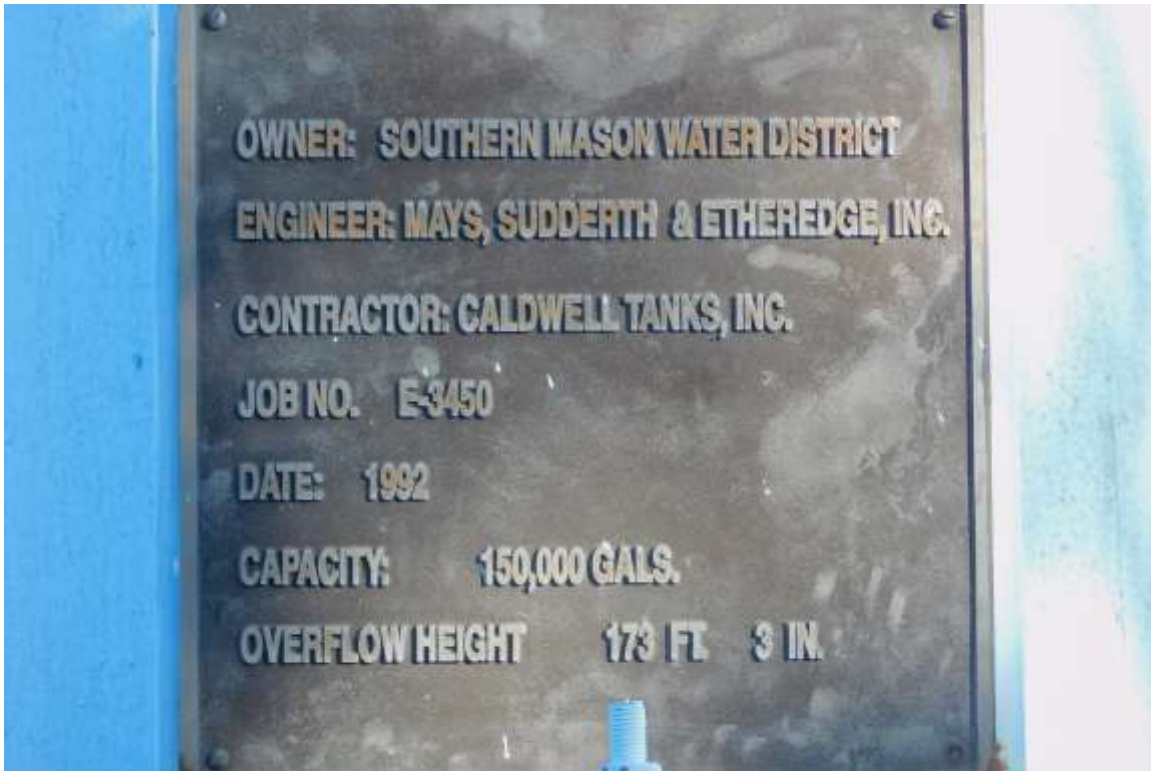
Photo shows the name plate.

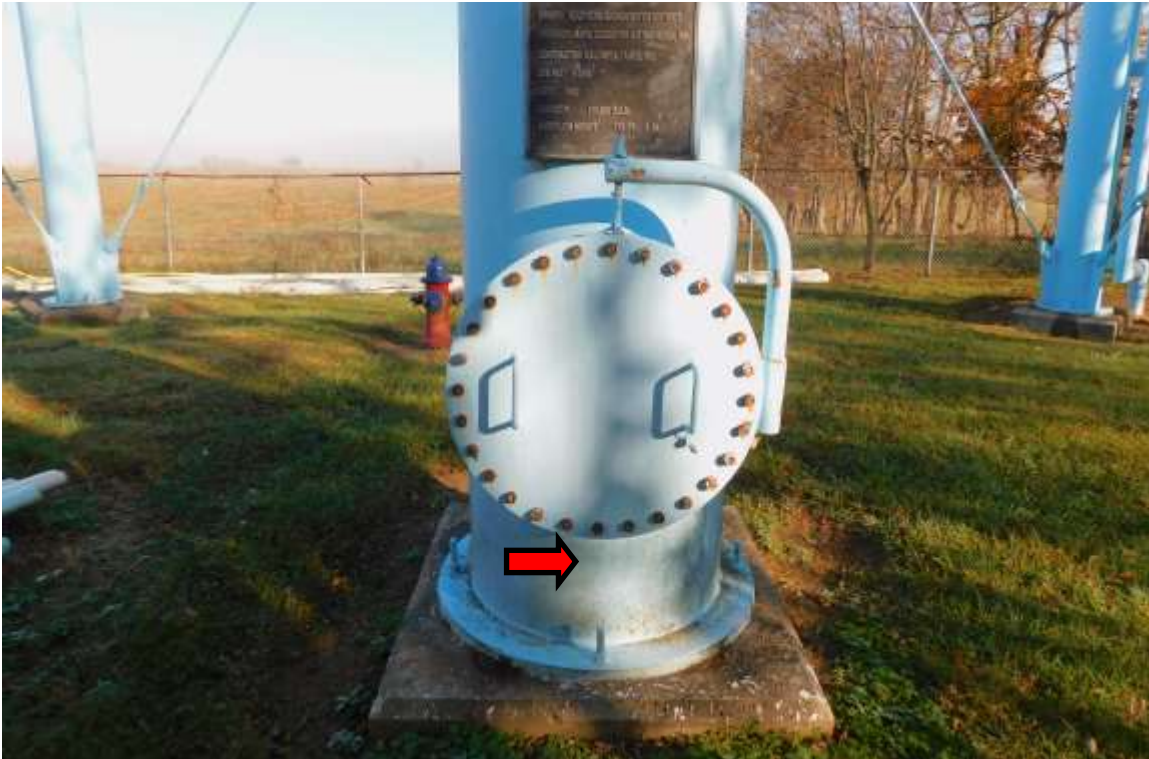
Photo shows the condition of the riser manway. **OSHA 1910.146(c)(2)** states “*If the workplace contains permit spaces, the employer shall inform exposed employees, by posting danger signs or by any other equally effective means, of the existence and location of and the danger posed by the permit spaces. NOTE: A sign reading **DANGER -- PERMIT-REQUIRED CONFINED SPACE, DO NOT ENTER** or using other similar language would satisfy the requirement for a sign.*”

Post Permit Required-Confined Space Entry sign.

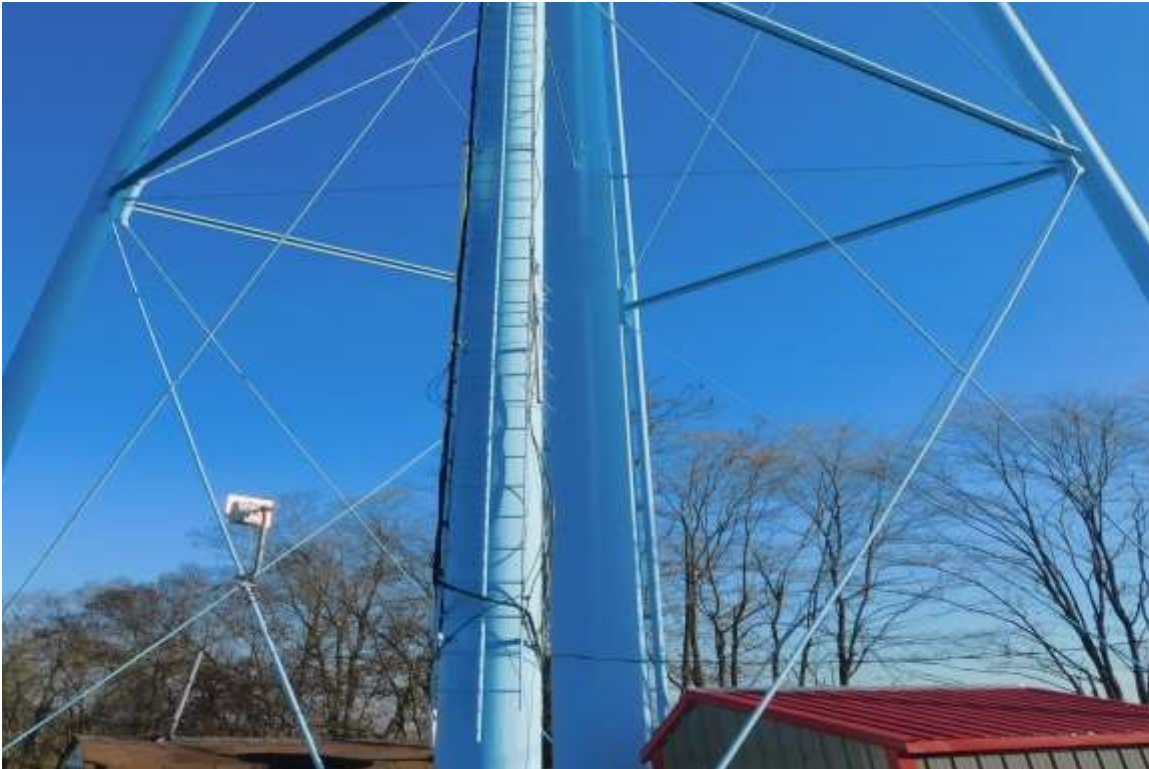
Tower access ladder in above photo is not equipped with anti-skid rungs. **OSHA 1926.1053(a)(6)(i)** states *“The rungs and steps of fixed metal ladders manufactured after March 15, 1991, shall be corrugated, knurled, dimpled, coated with skid-resistant material, or otherwise treated to minimize slipping.”*

- Install anti-skid rung cover tape to the existing ladder rungs.
- Install a lockable ladder guard to prevent unauthorized access.
- Install a **Fall Protection Required** sign at ladder base.

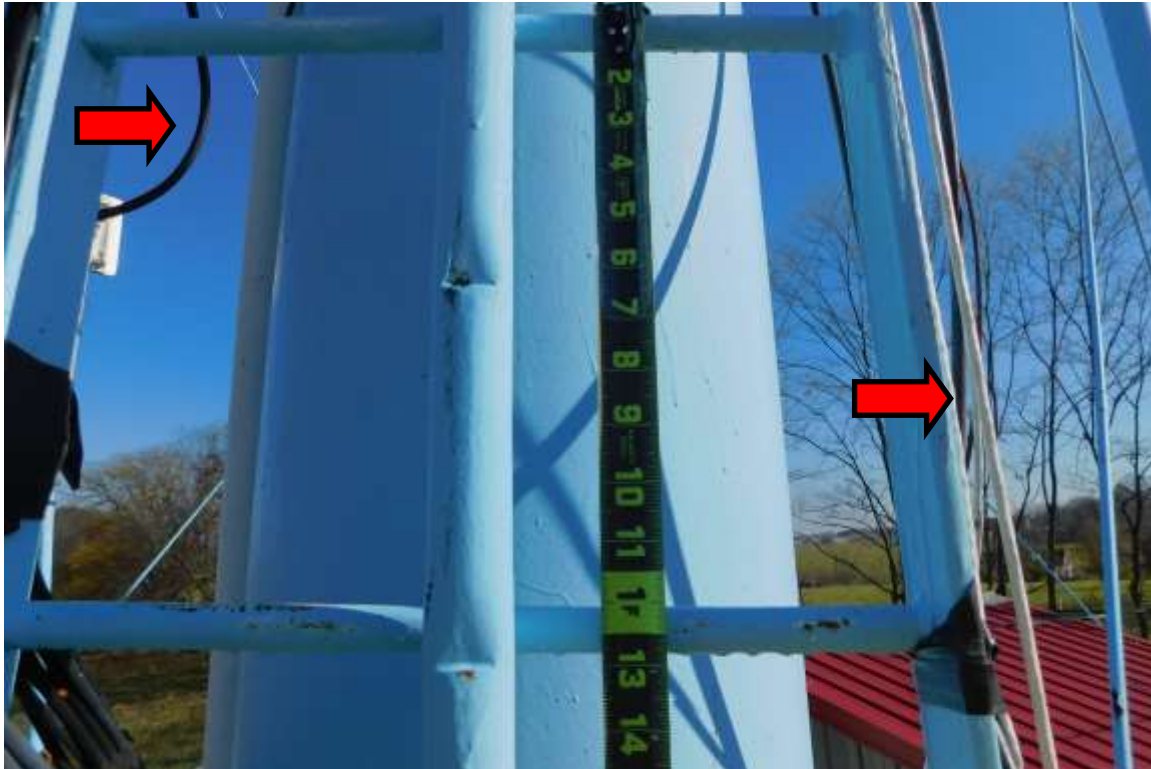
Photo shows more of the condition of the existing tower access ladder. Safe climbing procedure requires a person to climb a ladder with their hands on the side rails of the ladder and not the ladder rungs.

Remove the conduit from the ladder and securing it to standoffs.

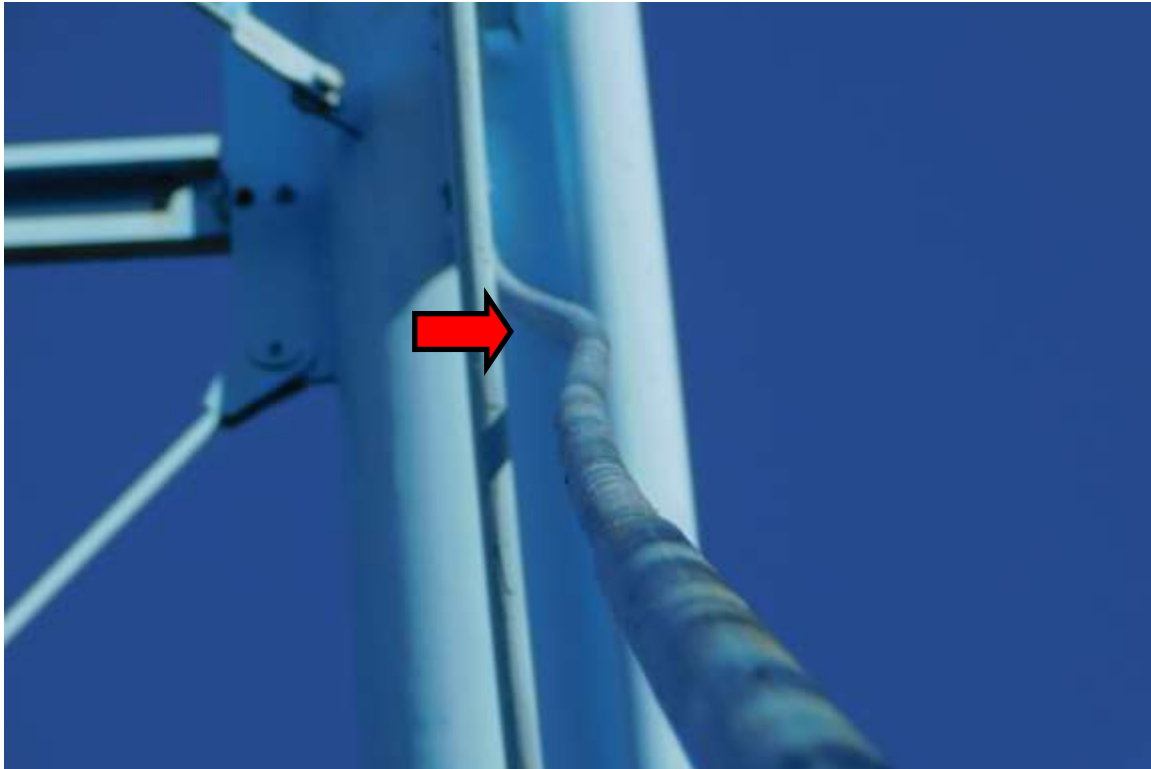
Photo shows the condition of the windage rods. The windage rods are designed to resist and stabilize the tower structure against wind and seismic loads combined with dead and live loads. The windage rods appear to be loose and need to be adjusted. **If the bracing remains loose, a sudden collapse could occur.**

Adjust the windage rods and riser stay rods as needed.

This repair should be done on EMERGENCY BASIS.

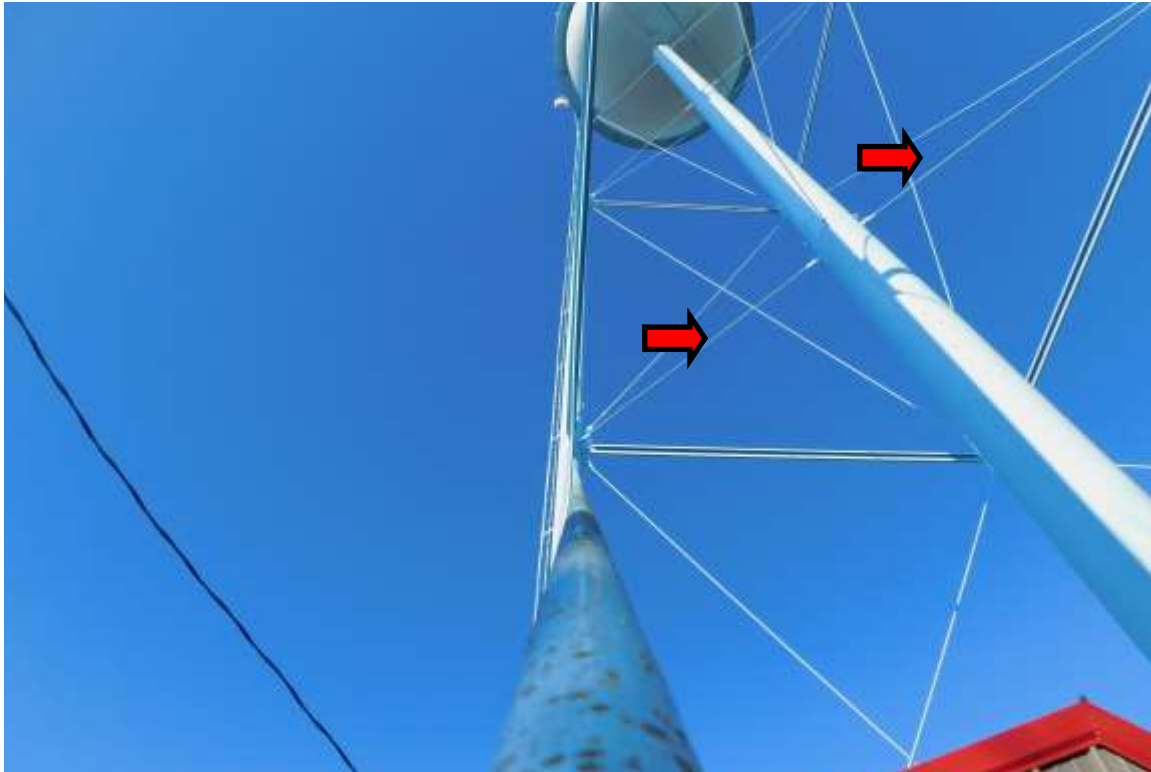
Photo shows the condition of the stay rods.

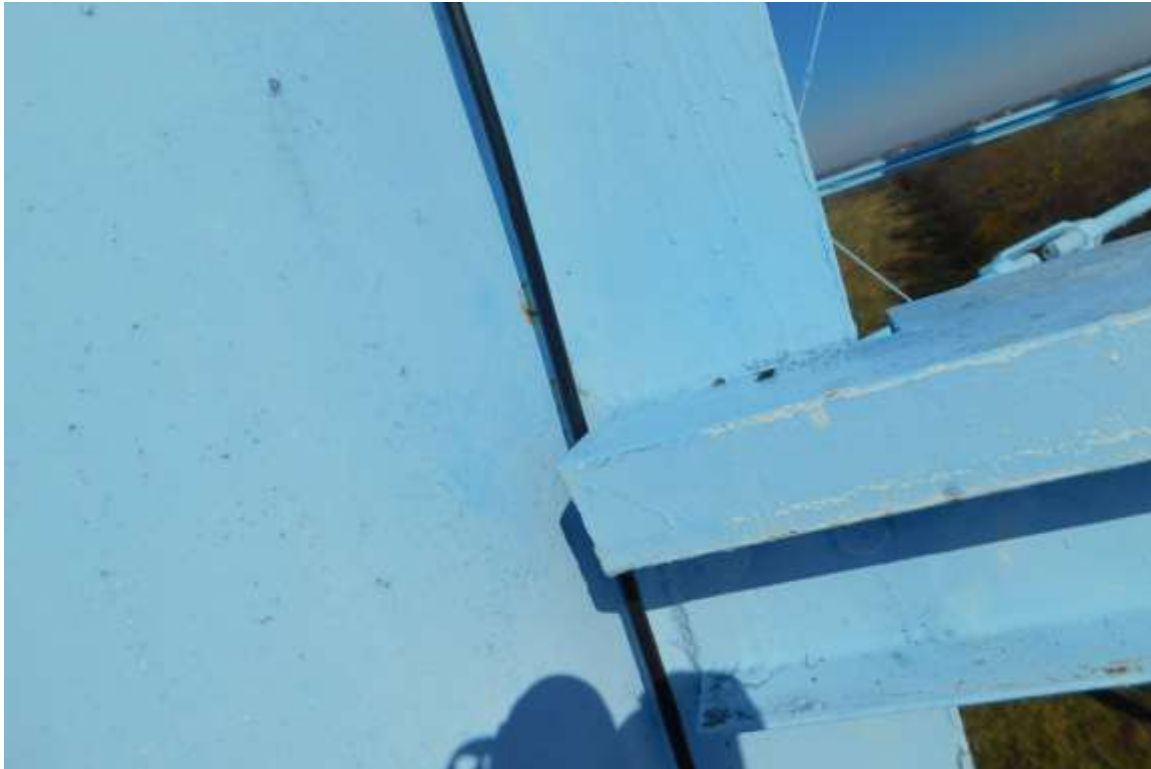
Photo shows the condition of the strut end connections. The strut ends have been sealed welded and appear to be in good condition.

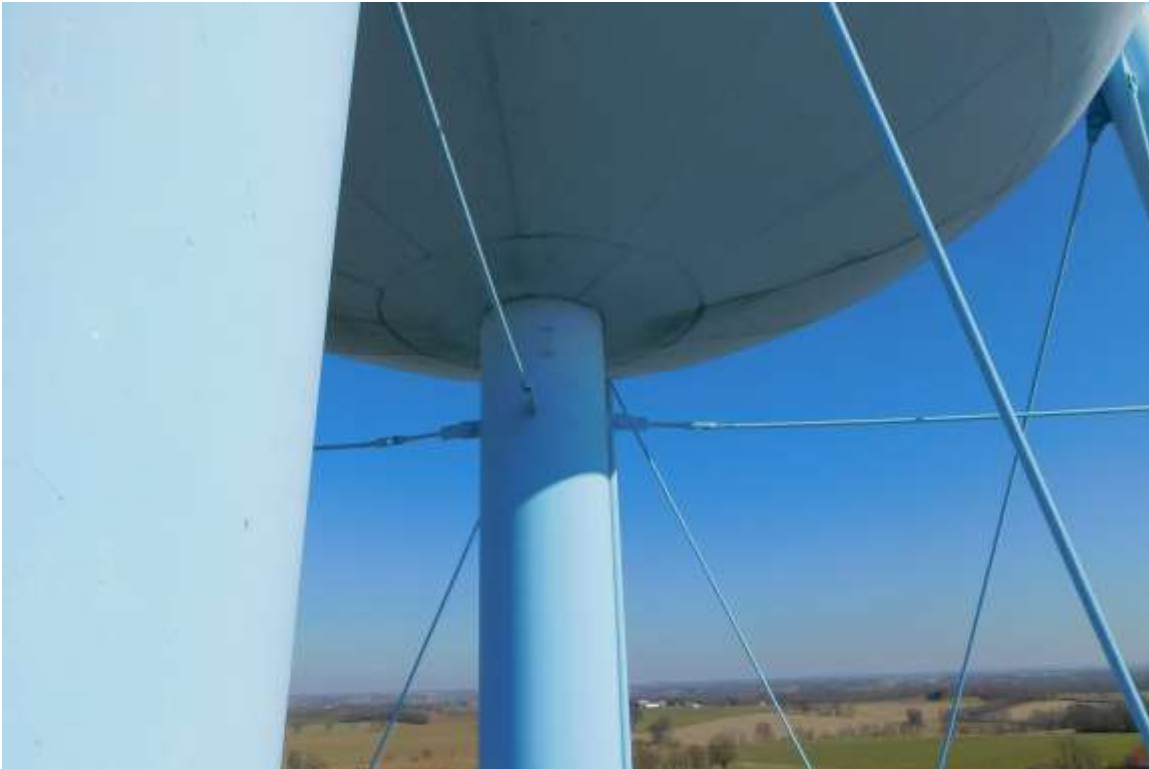
Photo shows the condition of the riser pipe and bowl. The connection appears to be in good condition.

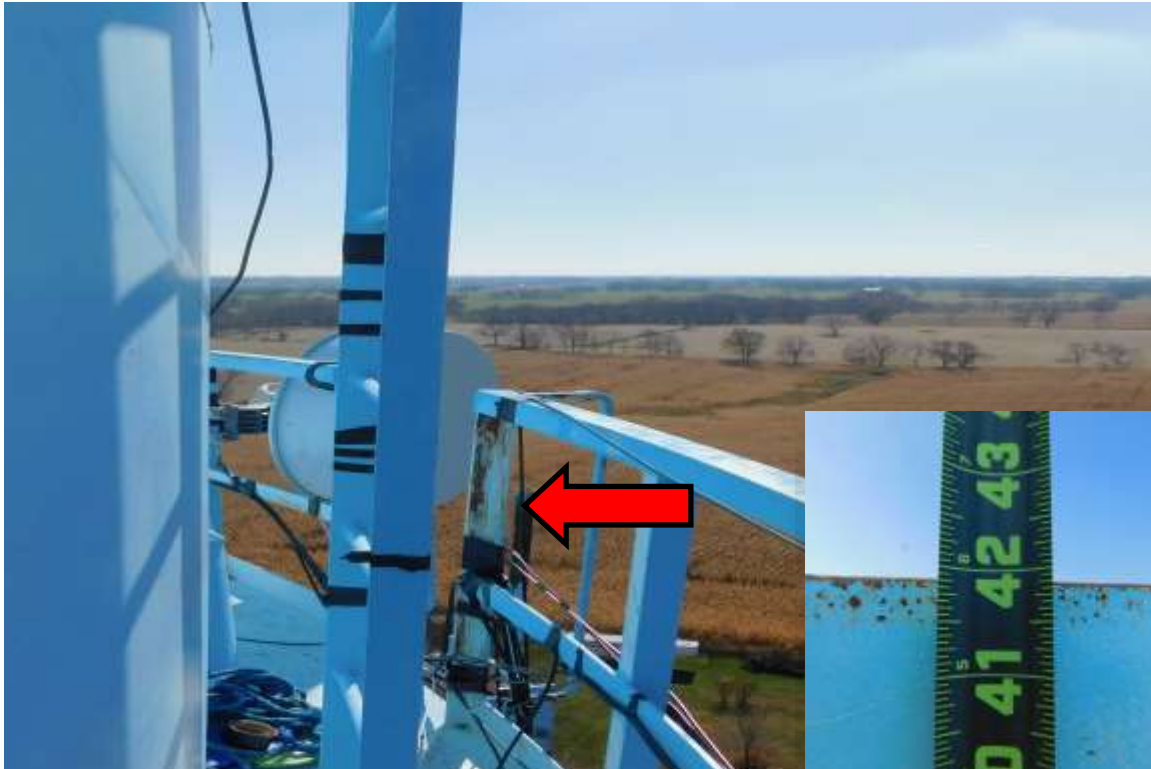
Photo shows the condition of the existing balcony handrail system. The handrail is not the required 42" height. **OSHA standard 29 CFR 1910.23 (a)(2)**, states *"Every ladderway floor opening or platform shall be guarded by a standard railing with standard toeboard on all exposed sides (except at entrance to opening), with the passage through the railing either provided with a swinging gate or so offset that a person cannot walk directly into the opening."*

Install a swing gate or safety chains at the ladder junction.

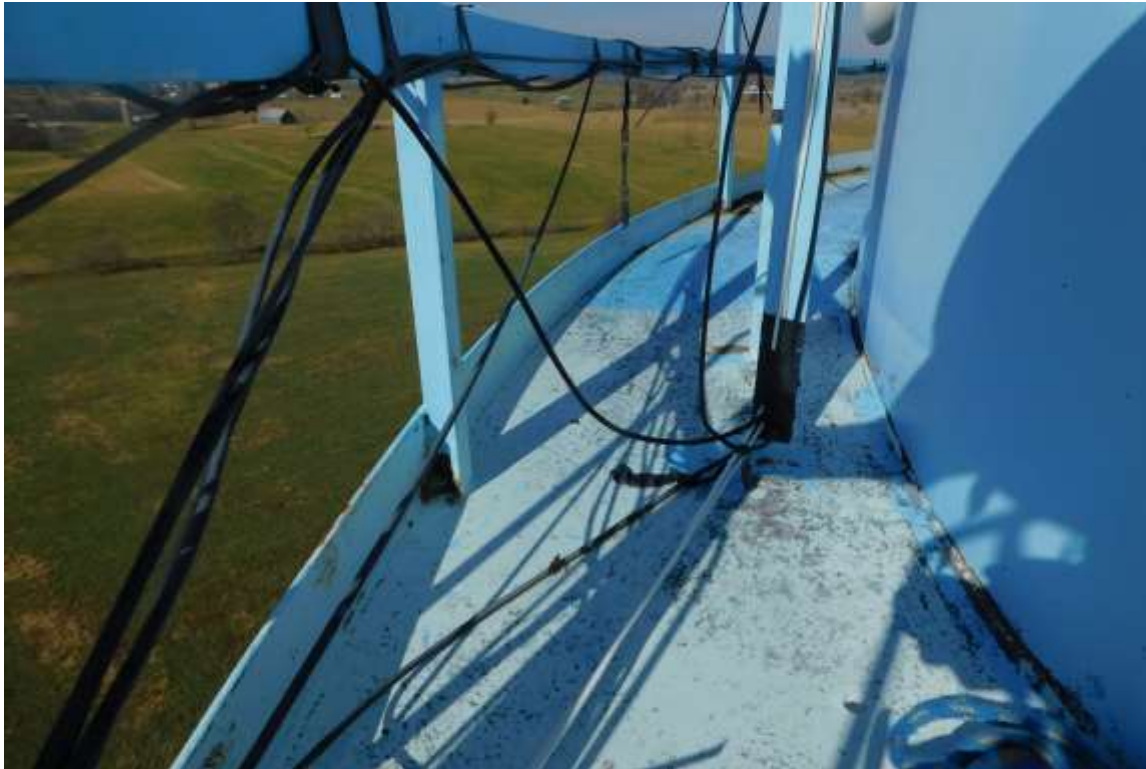
Photo shows more of the condition of the existing balcony handrail system. Notice the mounted conduit is coming loose, creating a safety hazard.

Secure the conduit.

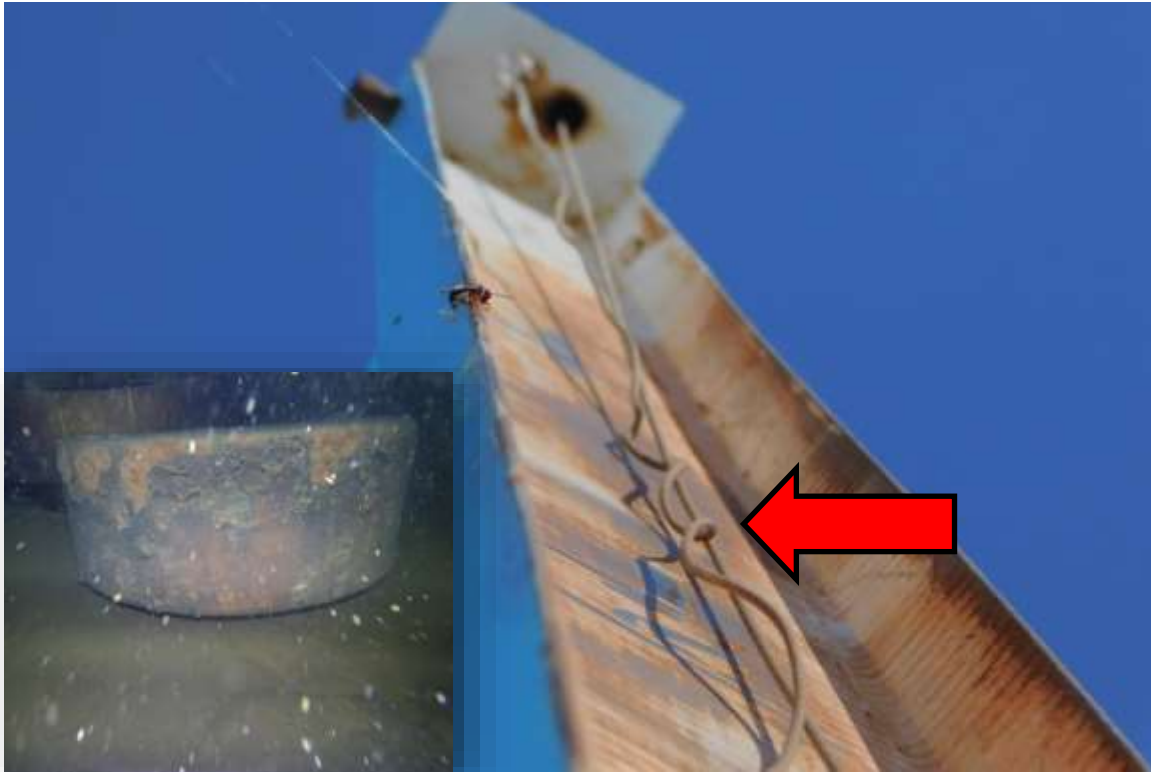
Photo shows the condition of the liquid level indicator. The indicator is damaged, unresponsive and requiring repair.

Repair the existing liquid level indicator by replacing the damaged parts as needed. The unit shall then be adjusted, calibrated and tested to insure compliance.

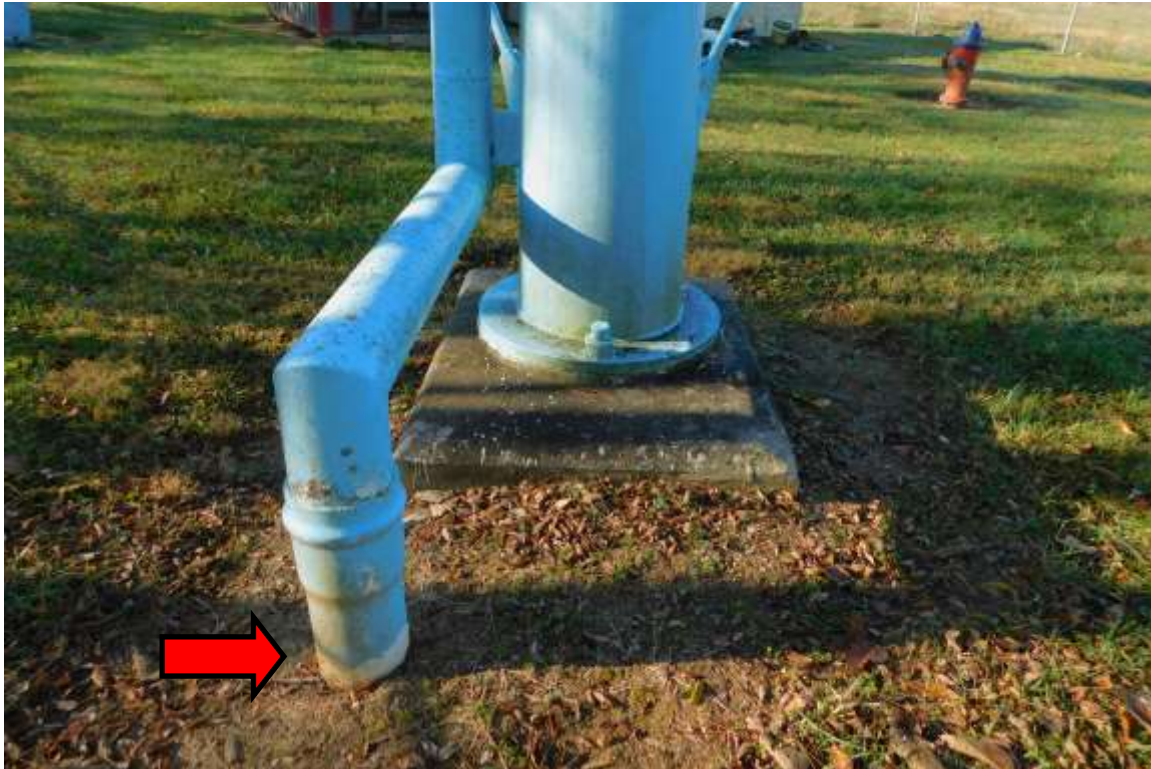
Photo shows the condition of the overflow pipe. Notice the overflow pipe does not have a visible air gap. If the connected drainage system becomes clogged or backflows, it could allow contaminants to enter the tank supply. **AWWA D100 -11** states *“A drainage-inlet structure or suitable erosion protection should be provided to receive discharge from the tank overflow. The overflow should not be connected directly to a sewer or a storm drain without an air brake.”*

Disconnect the pipe from the underground drain and install an air break complete with a flapper valve, screen and 4' x 6' splash pad to direct water away from the tank foundation.

This repair should be done on EMERGENCY BASIS.

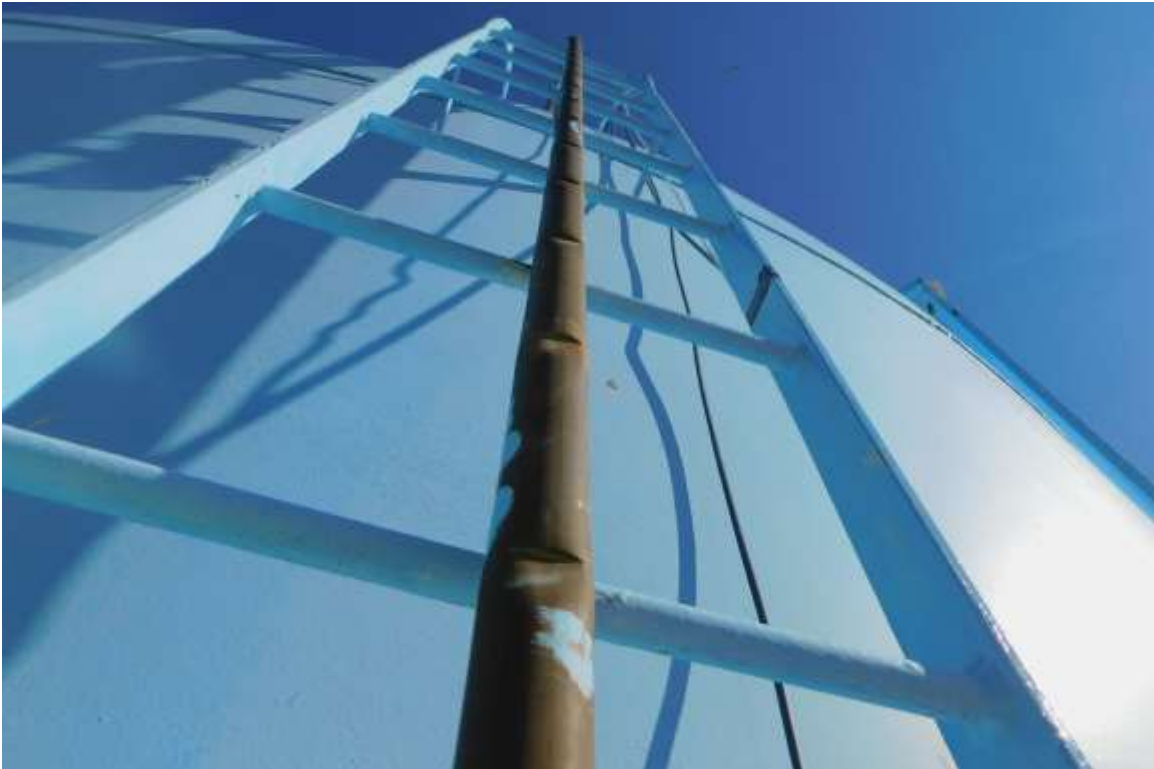
Shell ladder in above photo is not equipped with anti-skid rungs. **AWWA D100-11 5.4.2.1 General.** states "Ladders shall have side rails not less than 2in. x 3/8 in. (51 mm x 9.5 mm), with a spacing between the side rails of not less than 16 in. (406 mm) and rungs not less than 3/4 in. (19 mm) round or square, spaced 12 in. (305 mm) apart on centers. Ladders shall not in any place have a backward slope. Ladders with a single point of connection, including rolling ladders, shall not be used. **Skid-resistant rungs shall be provided when specified.**

- Install anti-skid rung cover tape to existing ladder rungs.
- Install a cable type ladder safety device.
- Post a **Fall Protection Required** sign at base of ladder.

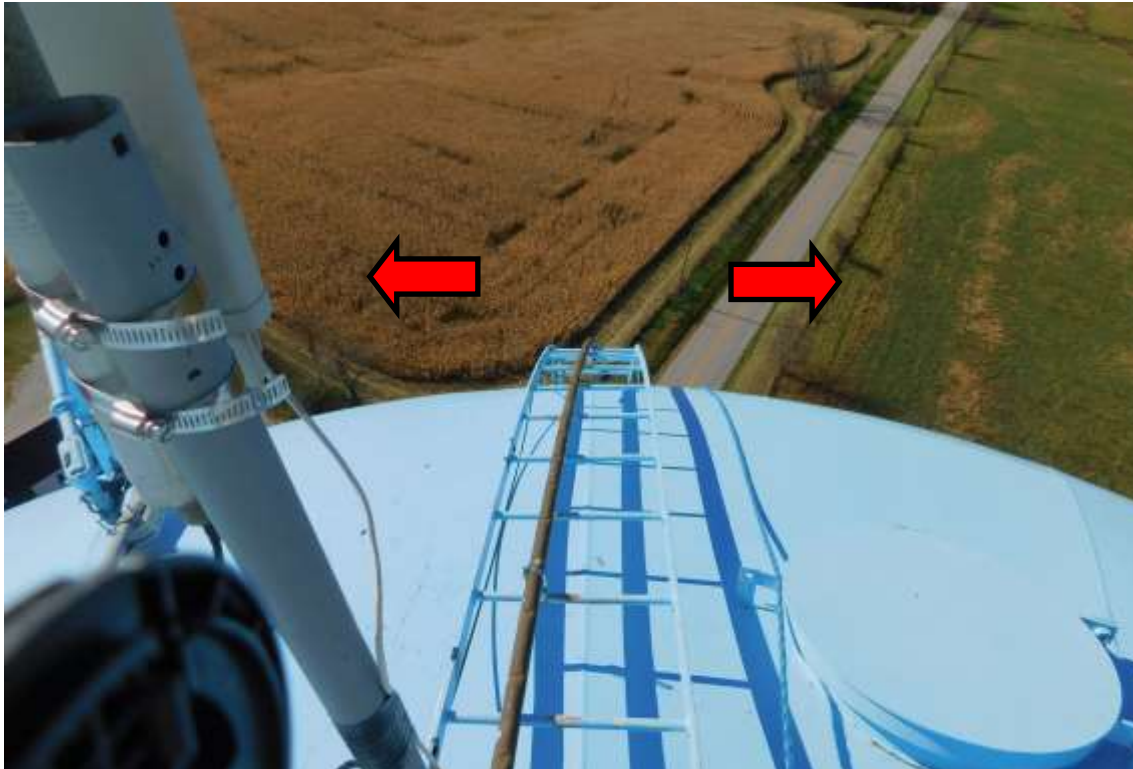
Photo shows the tank roof edge is not equipped with a required handrail system for fall protection. **OSHA 1910.21 (a) (1)** states "Every open-sided floor or platform 4 feet or more above adjacent floor or ground level shall be guarded by a standard railing (or the equivalent as specified)." **NFPA 22-2018 Sec. 4.14.3** states "Guardrails shall be constructed in accordance with OSHA 29 CFR 1910."

Install a compliant 42" high handrail system around the circumference of the tank roof, complete with toeboard, intermediate rail and a swing gate at the ladder opening.

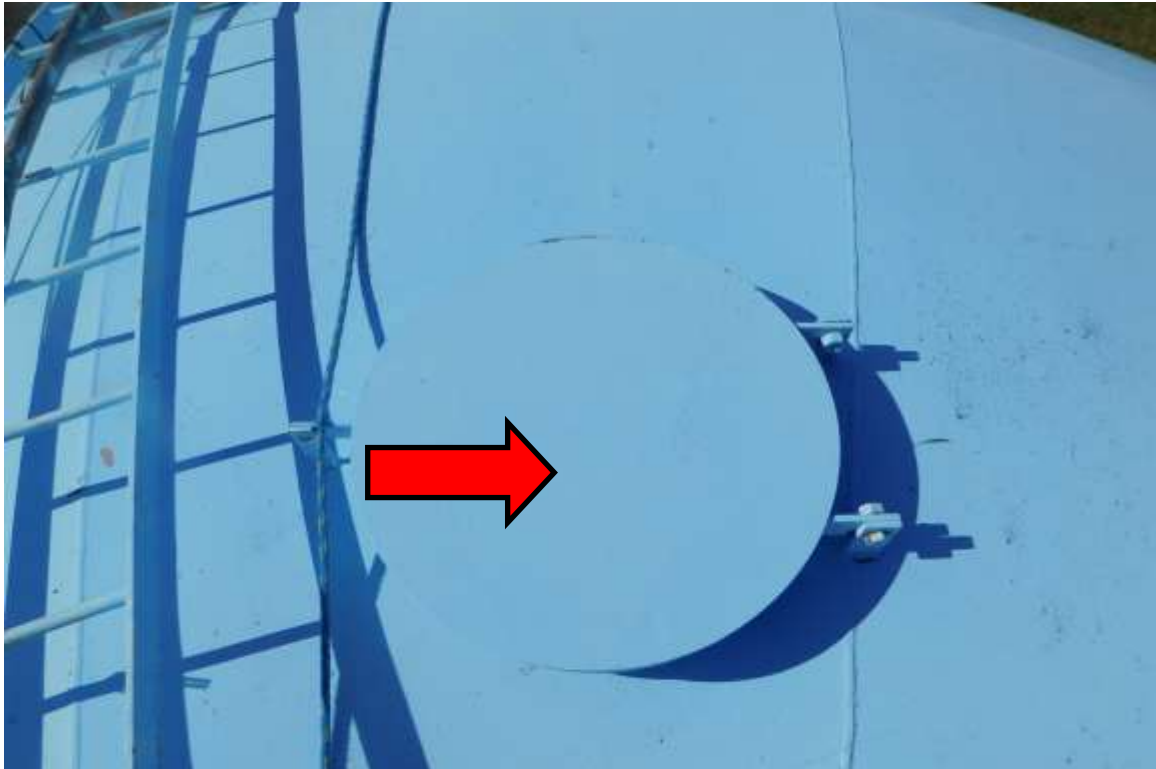
Photo shows the condition of the roof hatch. **OSHA 1910.146(c)(2)** states “*If the workplace contains permit spaces, the employer shall inform exposed employees, by posting danger signs or by any other equally effective means, of the existence and location of and the danger posed by the permit spaces.* **NOTE: A sign reading *DANGER -- PERMIT-REQUIRED CONFINED SPACE, DO NOT ENTER* or using other similar language would satisfy the requirement for a sign.**”

Post a **Permit Required-Confined Space Entry** sign.

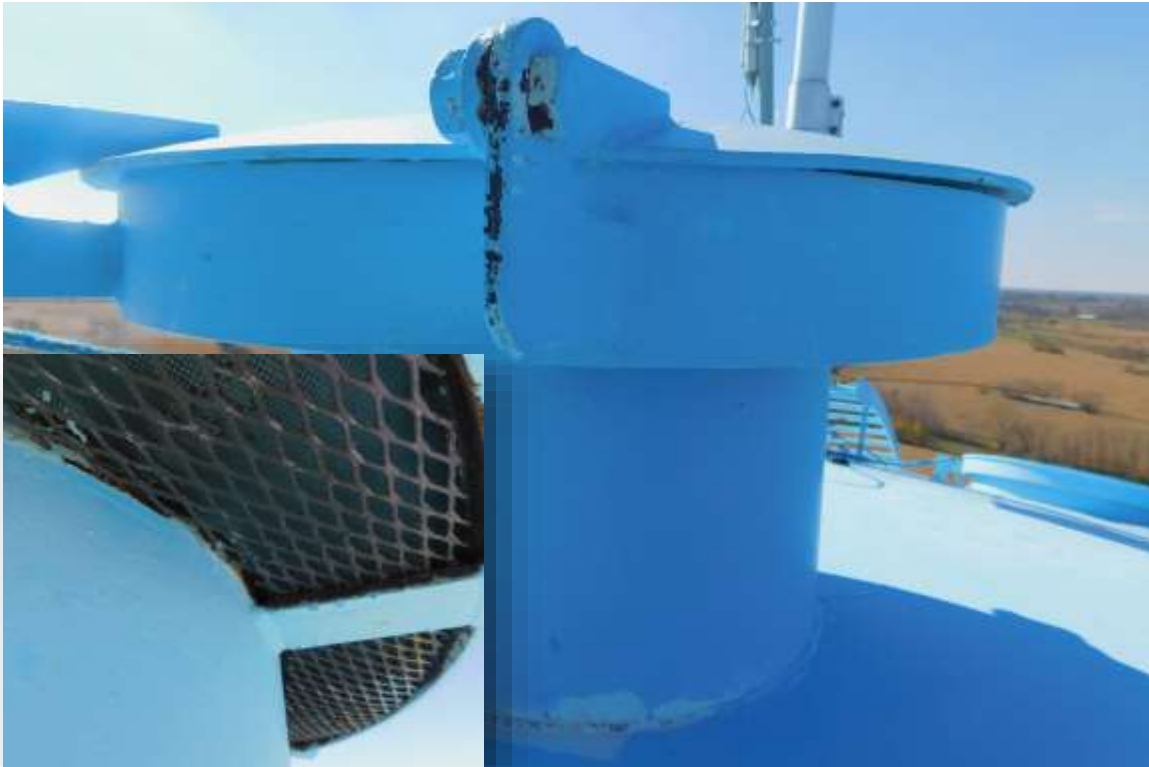
Photo shows the condition of the existing roof vent. The vent is not equipped with a relief mechanism per requirements. **AWWA D100-11 Sec. 7.5.2 Screening.** states *"The vent shall be designed and constructed to prevent the entrance of birds or animals. When the vent is provided with screening against insects, a **pressure-vacuum-screened vent or a separate pressure-vacuum relief mechanism shall be provided** that will operate in the event that the screens frost over or become clogged. The screens or relief mechanism shall not be damaged by the occurrence and shall return automatically to operating position after the clogging is cleared."*

Install a new vent equipped with the pressure-vacuum mechanism.

This should be done on EMERGENCY BASIS.

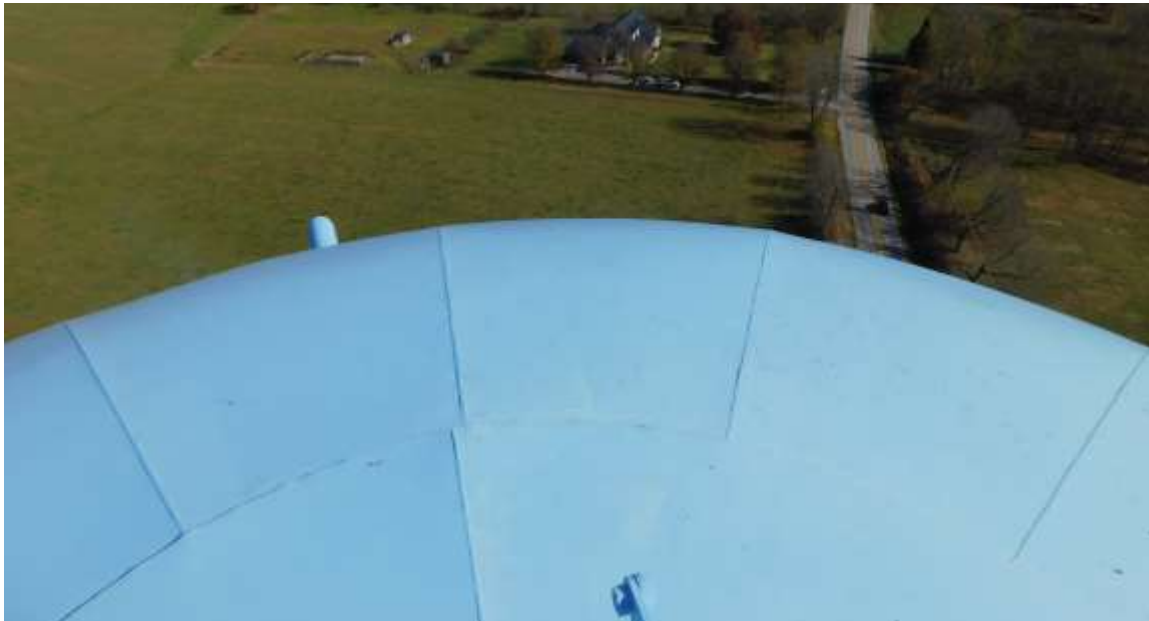
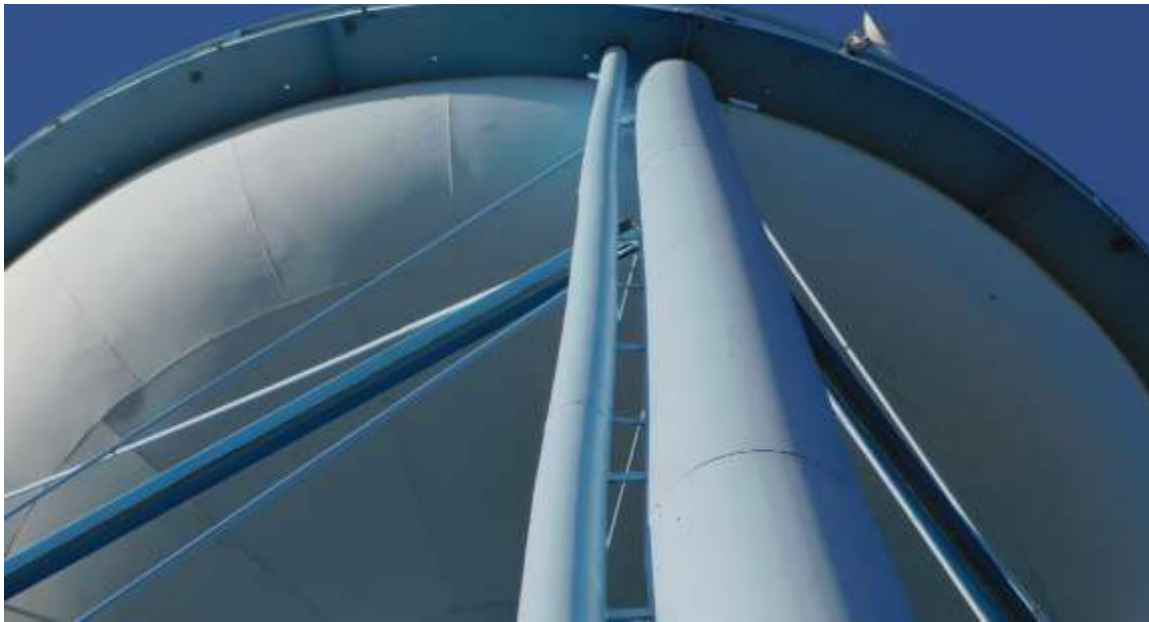
Photos show the tank exterior coating system.

Pressure wash the tank exterior with biodegradable detergent (max 3,500 psi), then remove all loose rust and scale with wire brushes and hand scrapers in accordance with SSPC#2 (hand tool cleaning), spot prime, and apply two (2)
