COMPLETE RESTORATION, LLC

Name of Tank: MAYS LICK

Date of Inspection: 11/03/2022

150,000 Gallon E.W.T.

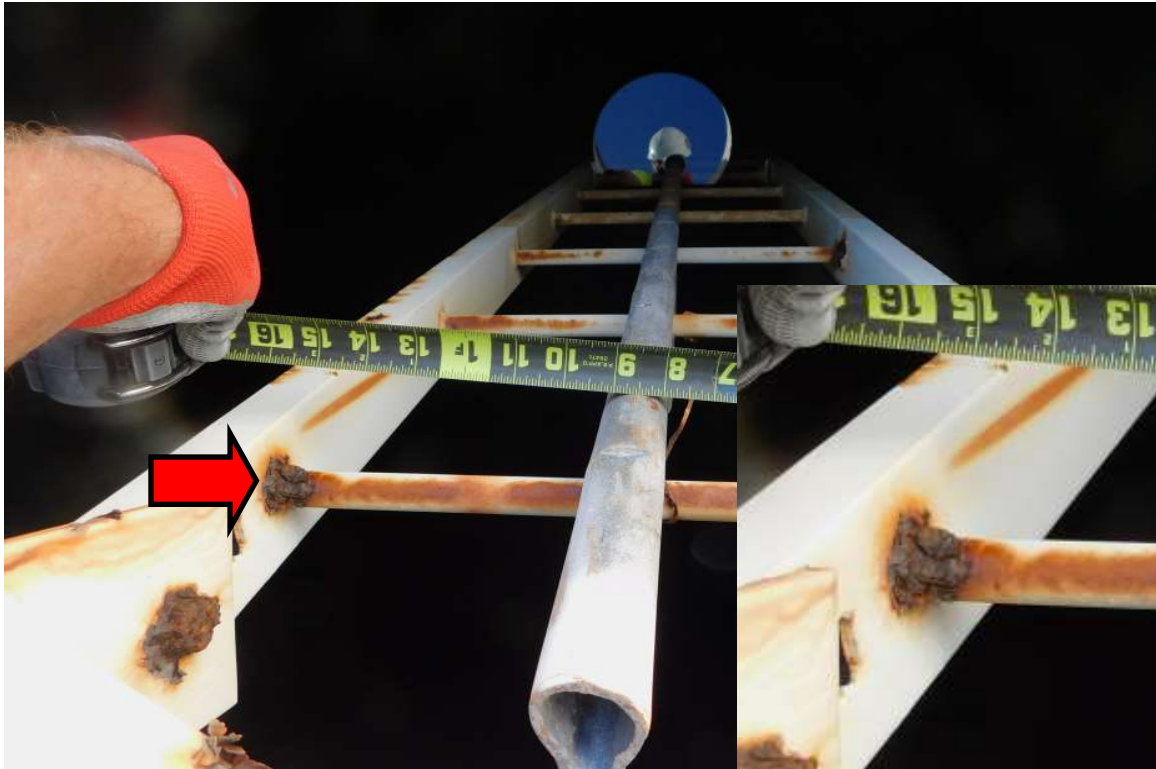
Interior shell ladder in above photo is seriously deteriorated. **OSHA 1926.1053 (b)(17)** states “Fixed ladders with structural defects, such as, but not limited to, broken or missing rungs, cleats, or steps, broken or split rails, or corroded components, shall be withdrawn from service until repaired.”

Tag the existing interior ladder out immediately, then installing a new OSHA complaint ladder equipped with a stainless steel cable safety device.

This repair should be done on EMERGENCY BASIS.

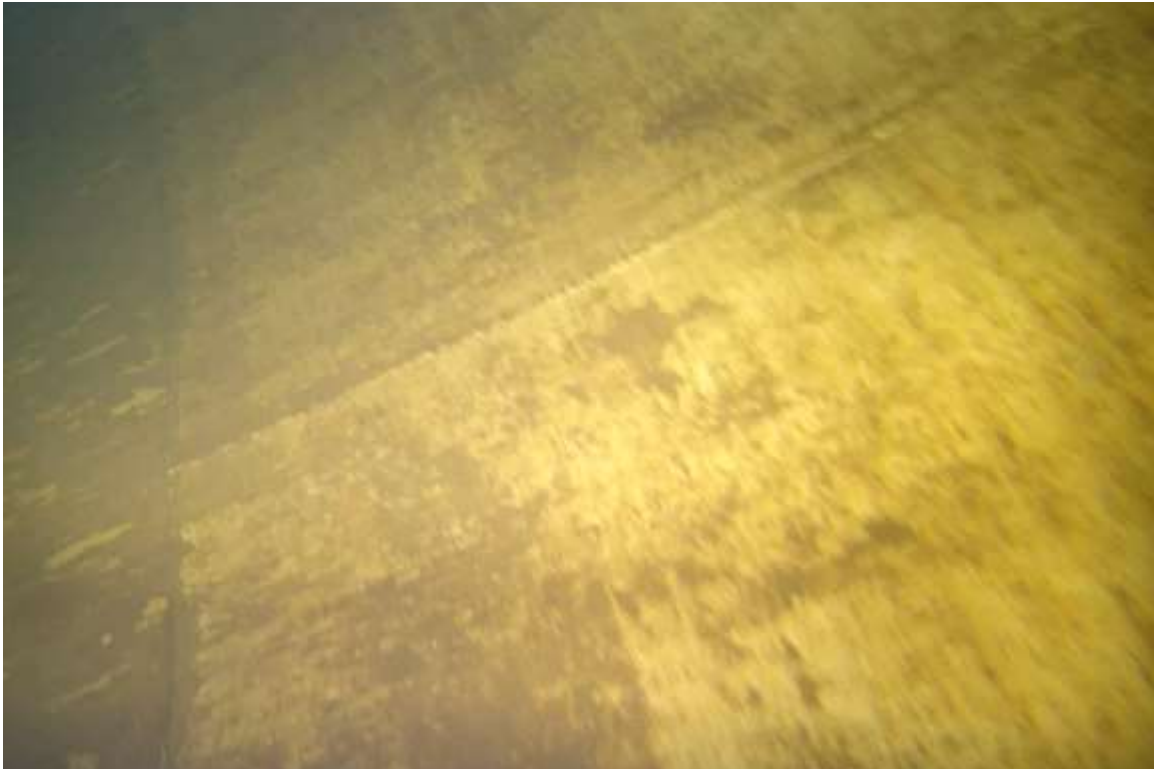
Photo shows silt and debris in the tank. This should be completed to avoid the problems associated with excessive silt buildup.

Clean the tank out.

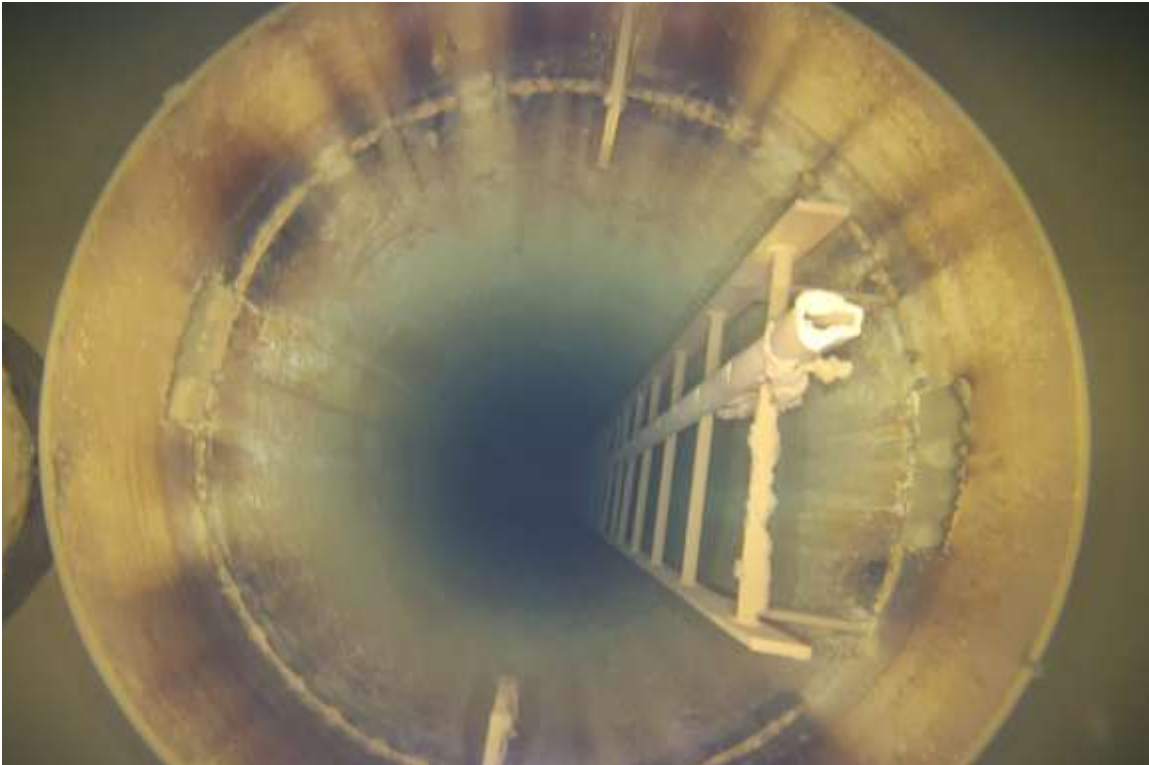
Photo shows the condition of the riser pipe opening. The riser opening is not equipped with a safety grating in accordance with **AWWA D100-11 Sec. 5.1.1 Safety grill** and **OSHA 29 CFR 1910.23**.

Install a safety grate over the riser opening.

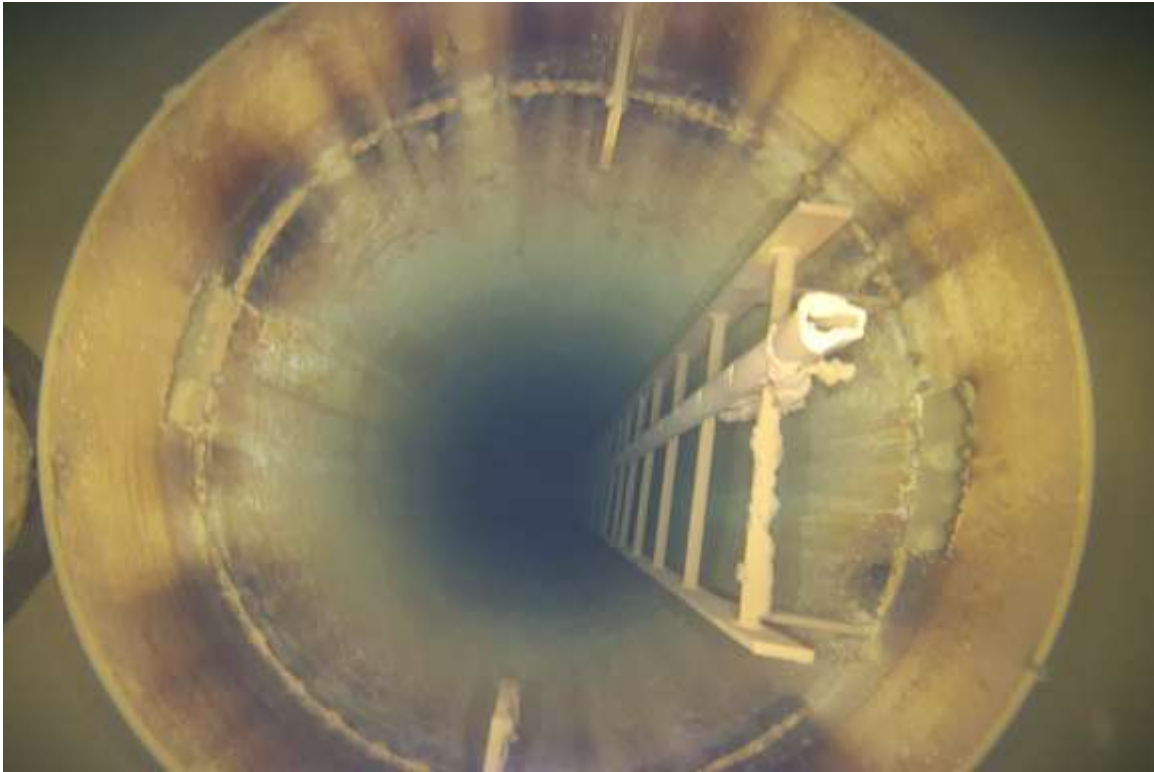
Photo shows the condition of the riser ladder.

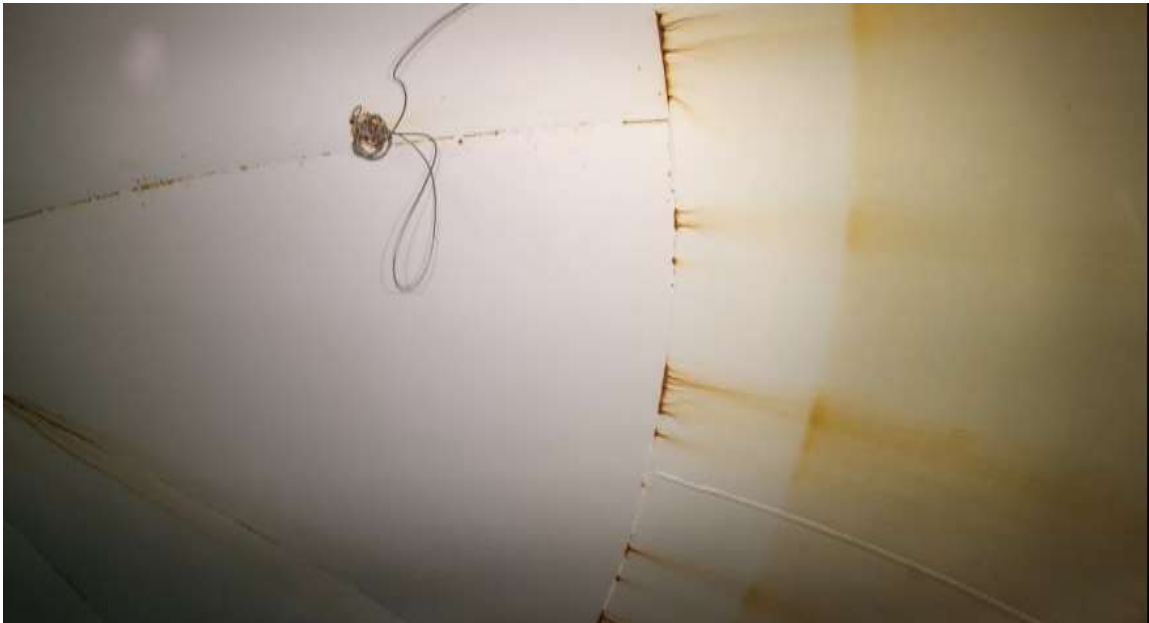
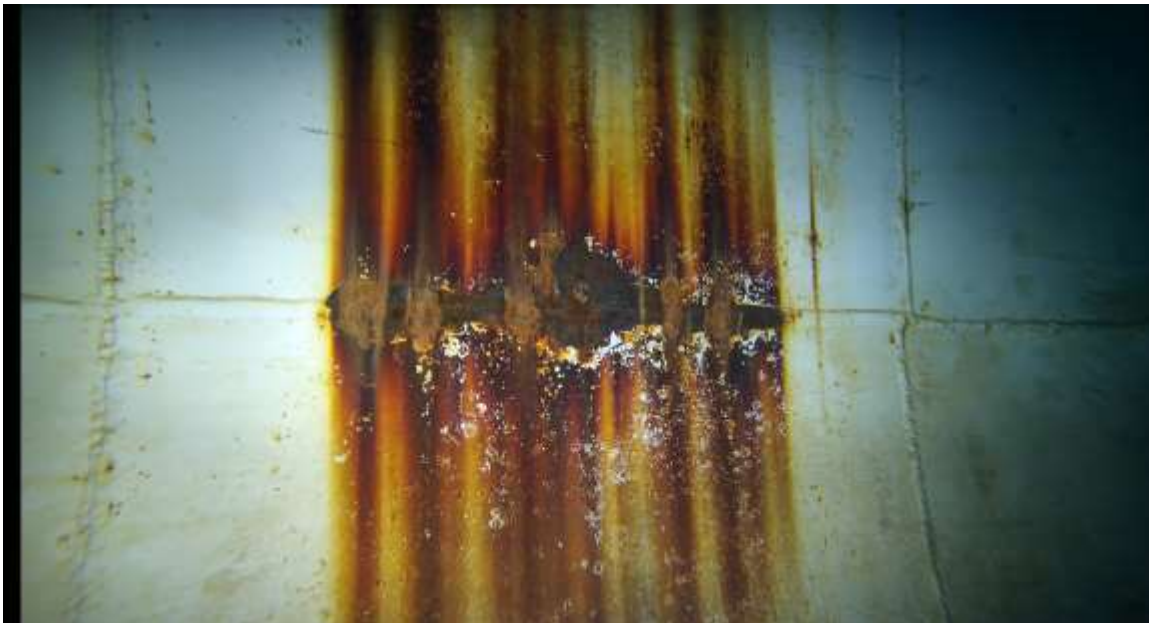
Photos show the condition of the interior liner. Notice the rust forming in various areas.

Sandblast all rusted and abraded areas of the tank interior to an SSPC #10 (near white blast) condition, brushblast all remaining areas, stripe coating all seams and welds, then applying two (2) full coats of epoxy to complete.

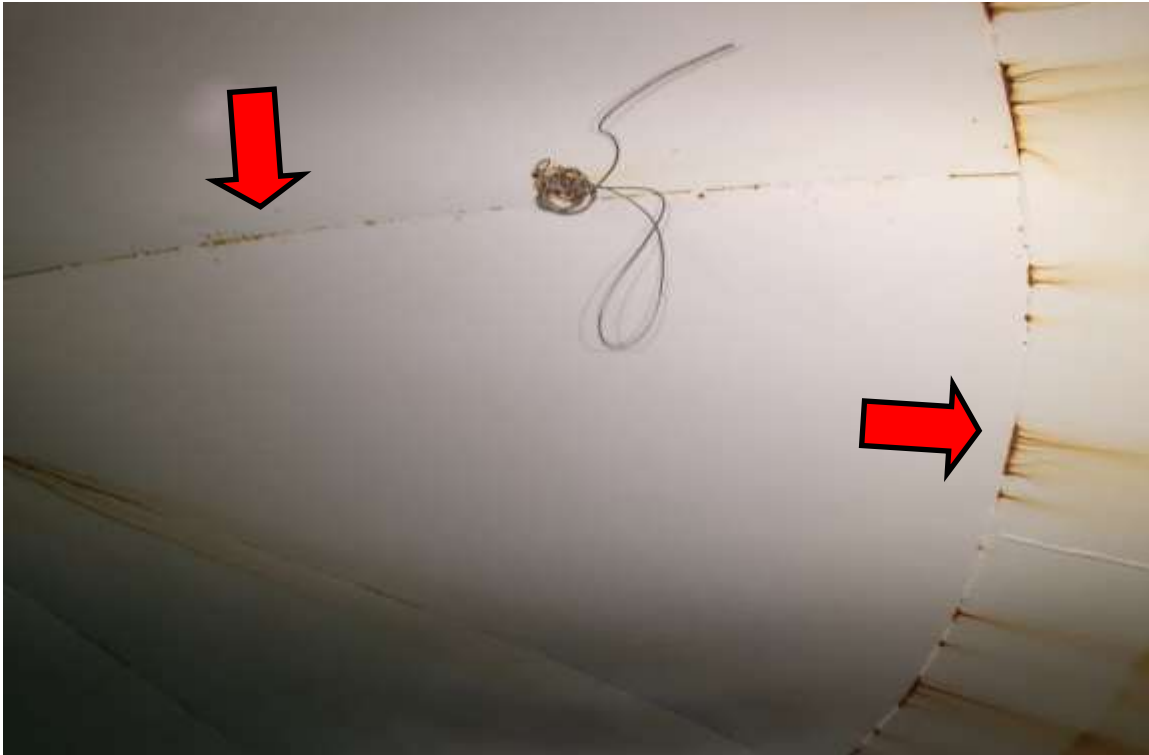
Photo shows the condition of the interior roof. Notice the rust forming at the roof lap seams. These seams are unwelded and therefore it is hard to completely seal during painting operations.

Seam seal all unwelded interior roof lap seams with caulk to prevent premature failure of the new interior coating.

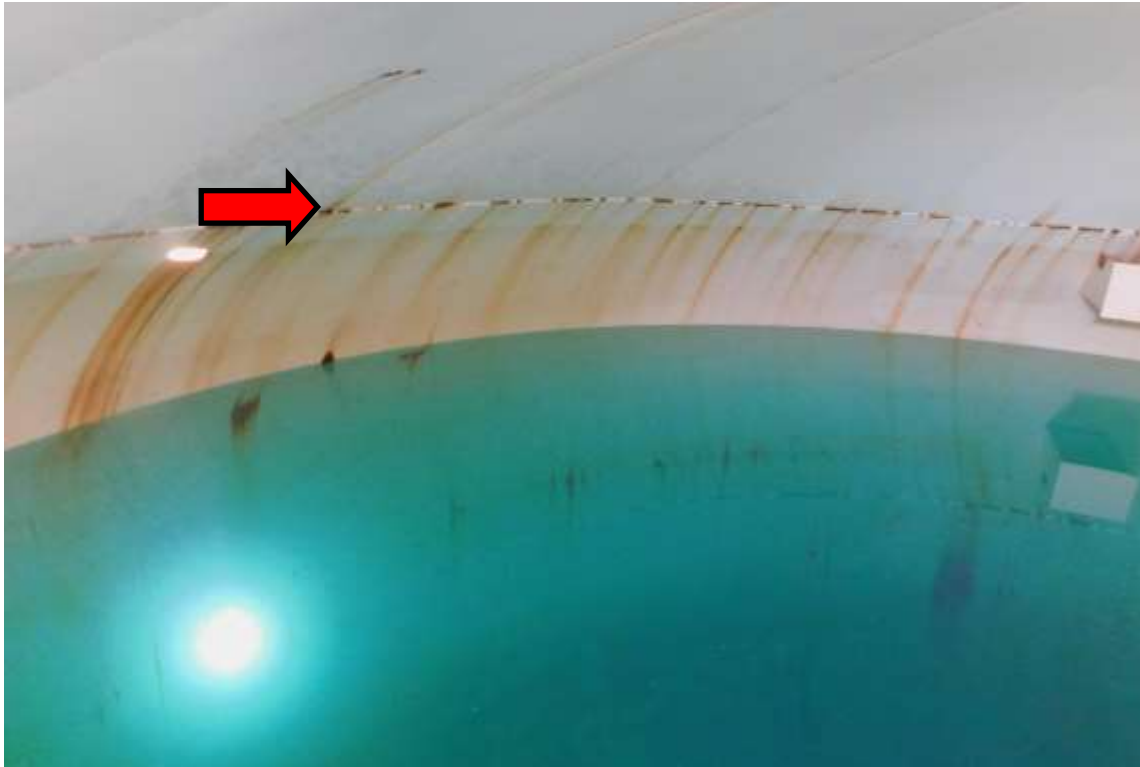
Photo shows the condition of the interior roof to shell connection. Notice the rust forming at the connection. These seams are not seal welded and therefore it is hard to completely seal during painting operations.

Seam seal around the circumference of the roof-to-shell connection with caulk to prevent premature failure of the new interior coating.

32	Seam seal around the circumference of the roof-to-shell connection with caulk to prevent premature failure of the new interior coating.
